York River Watershed Grants Program – Project Summary Report

Project name: Cider House Restoration at McIntire Garrison

York River Watershed Grant
Photos 2025

Structural Condition in Early 2025

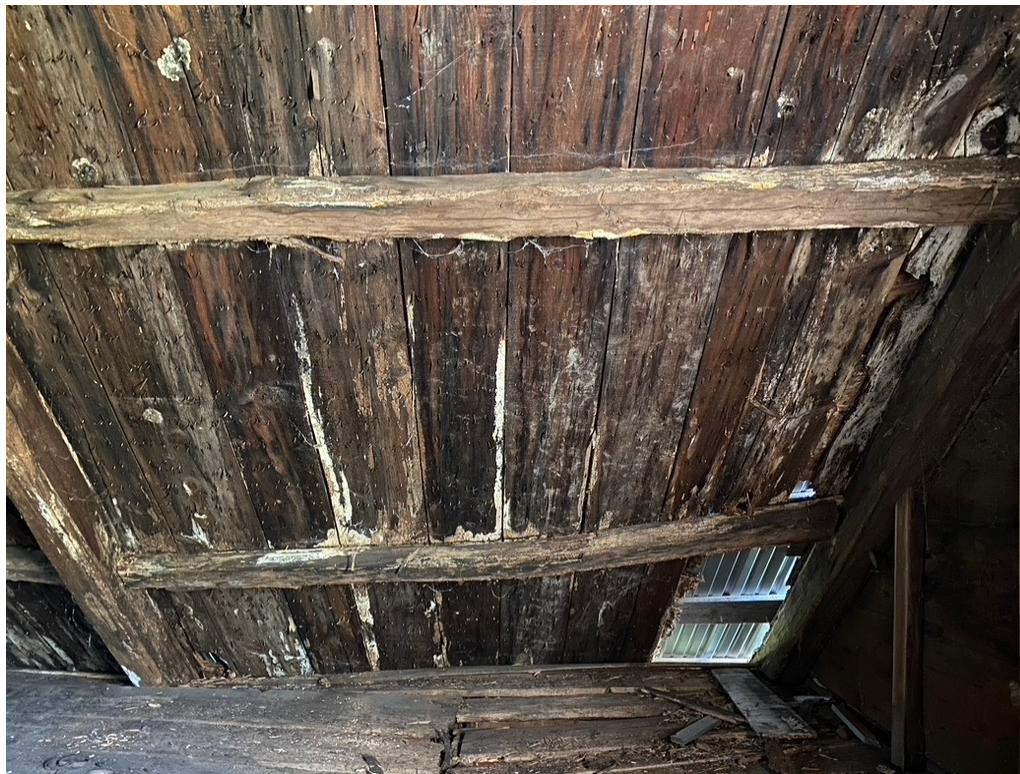
Compromised roof boards due to water infiltration.

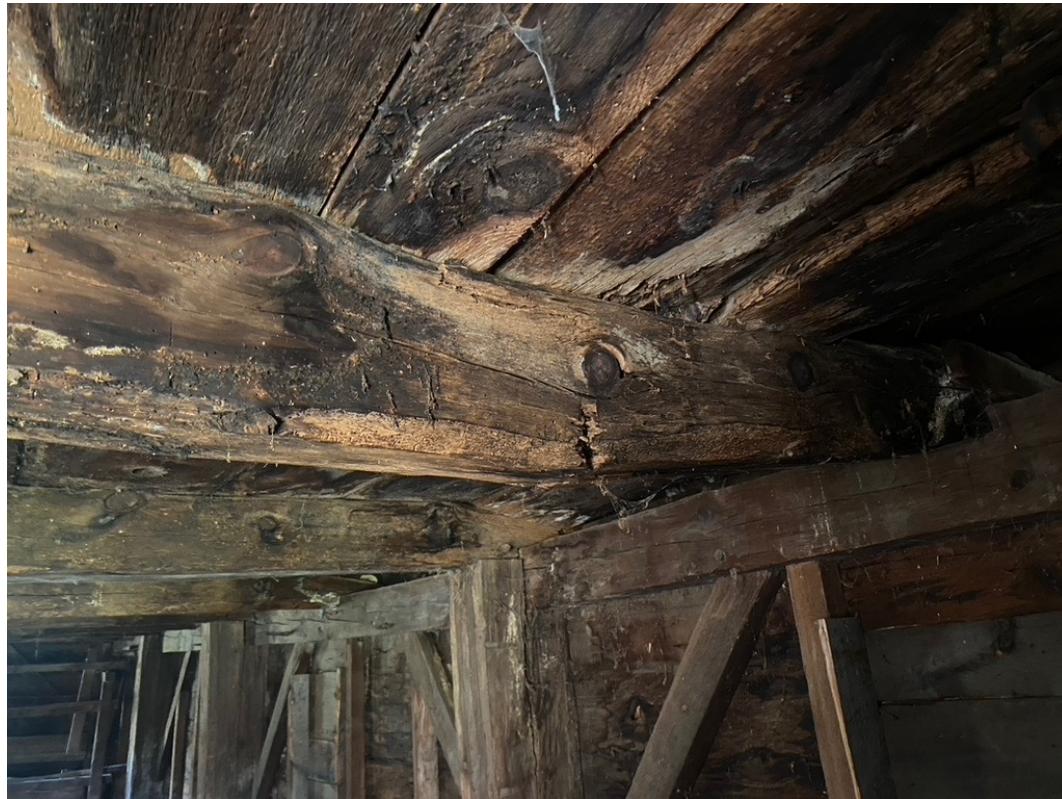
A rotted floor joist beam on the verge of collapse.

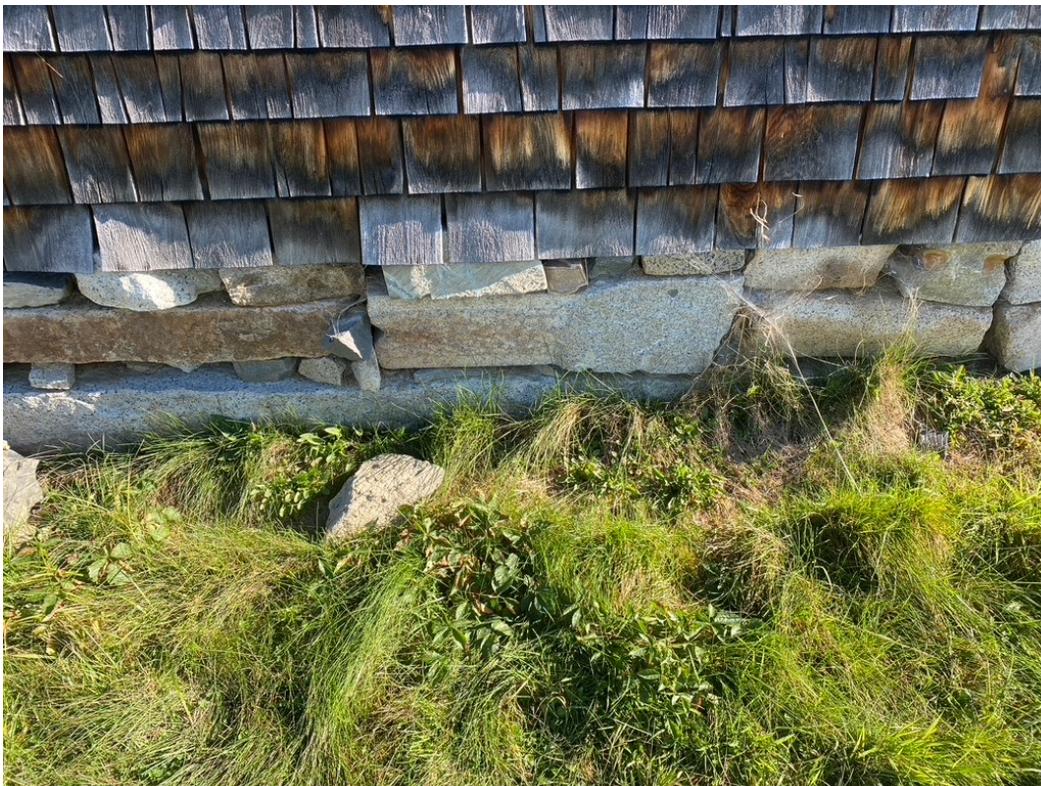
An unstable foundation with repurposed cemetery stone posts.

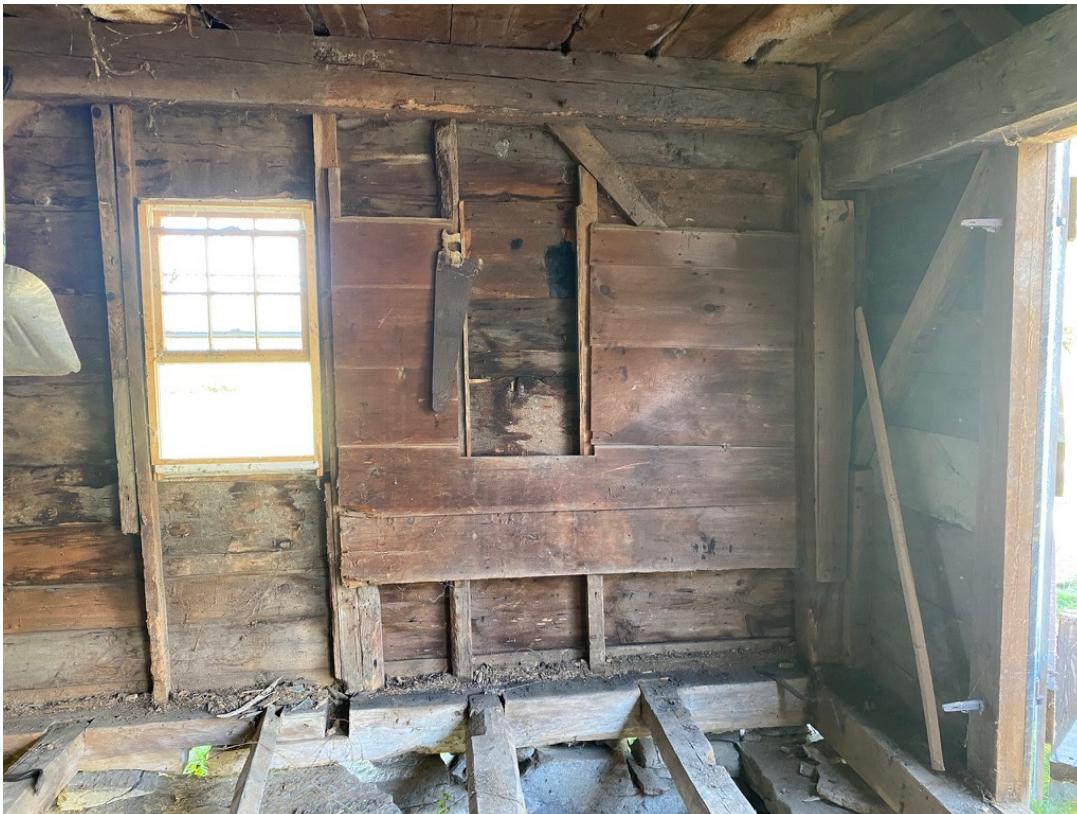
The NE first-floor corner of after flooring was removed.

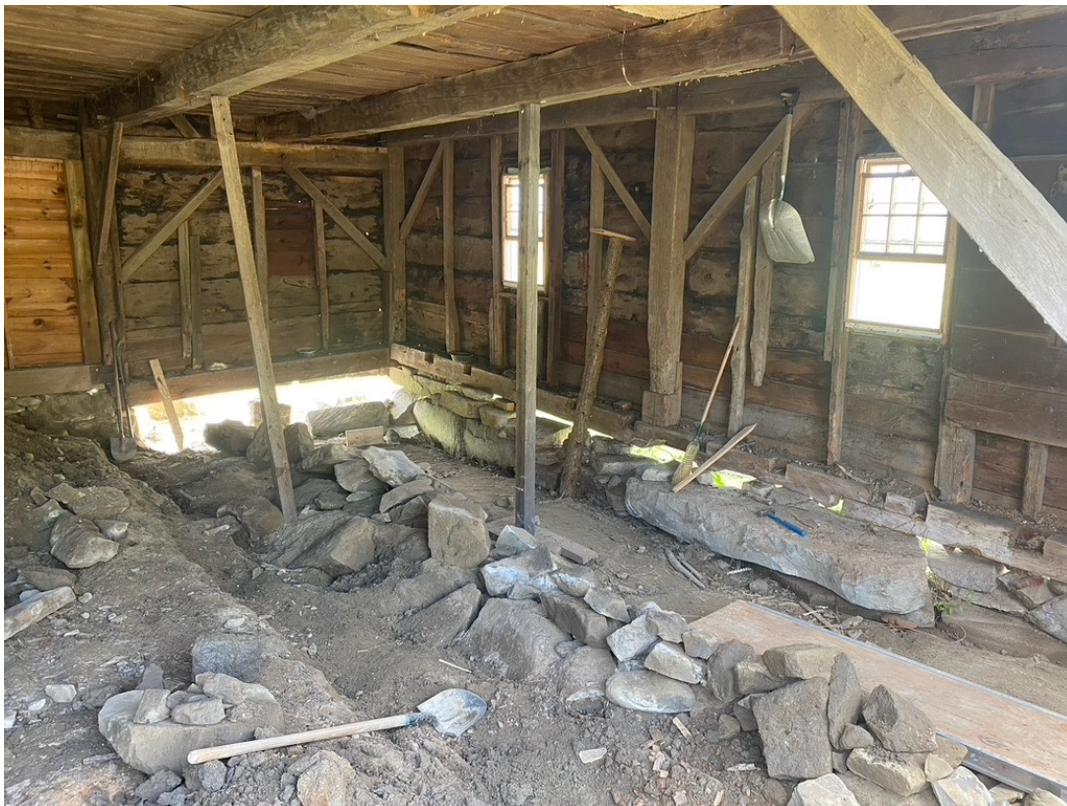
The north wall had shifted outward off the foundation.

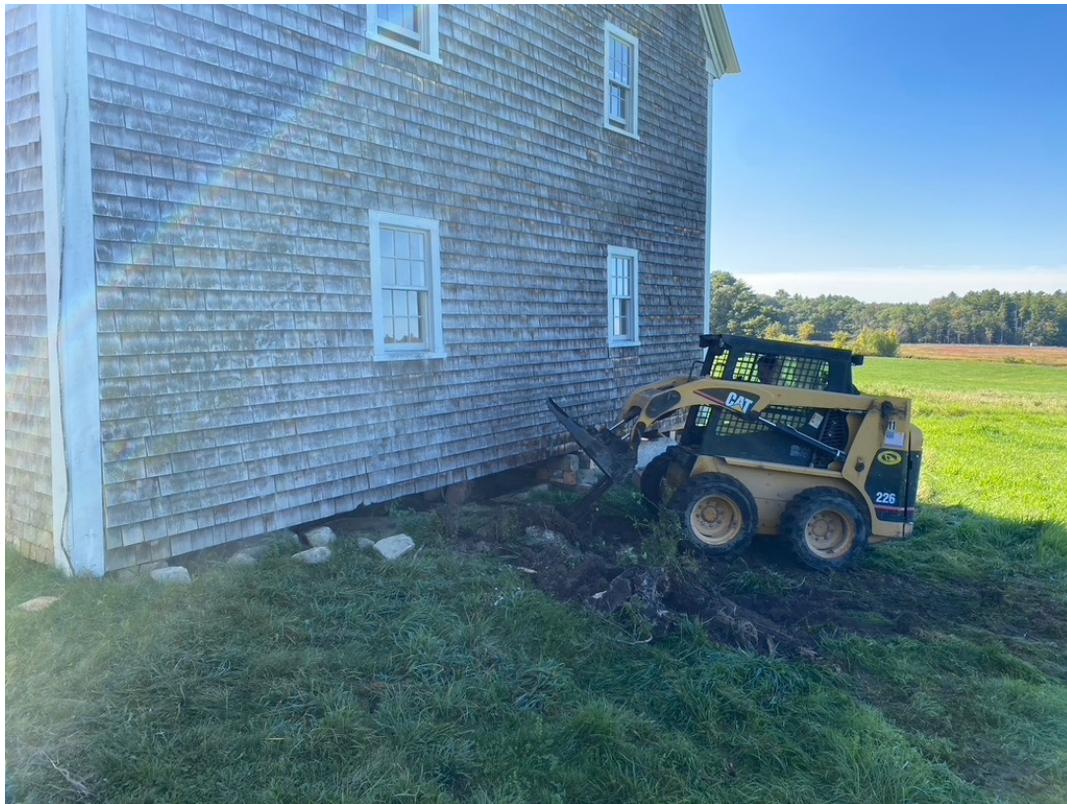
Removing the unstable foundation stones.

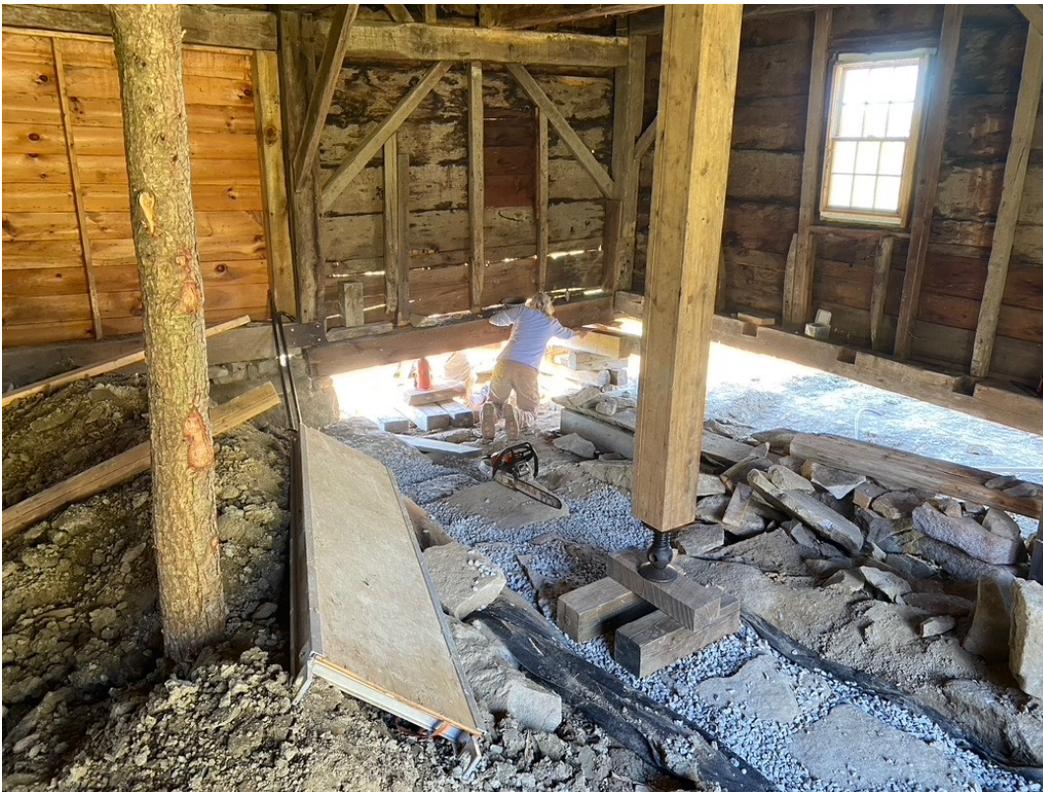
Preparing to dig foundation trench.

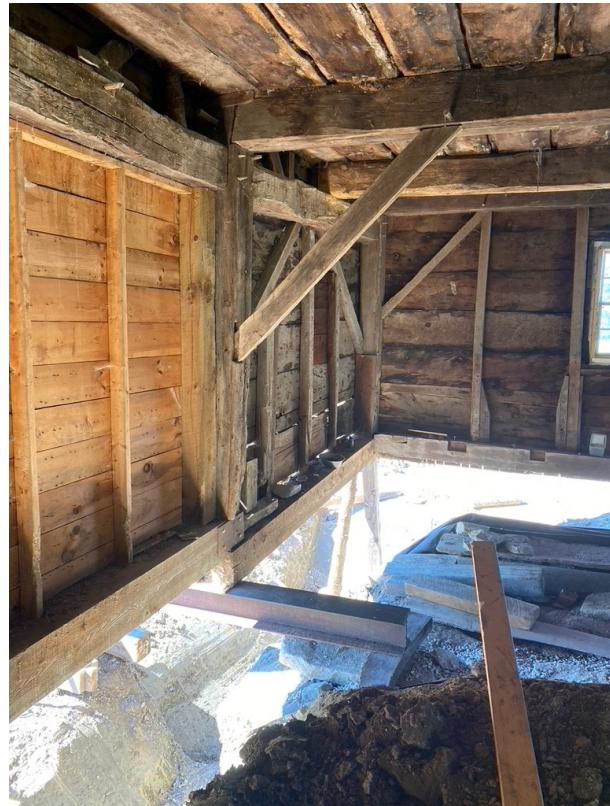
The trench with temporary steel support.

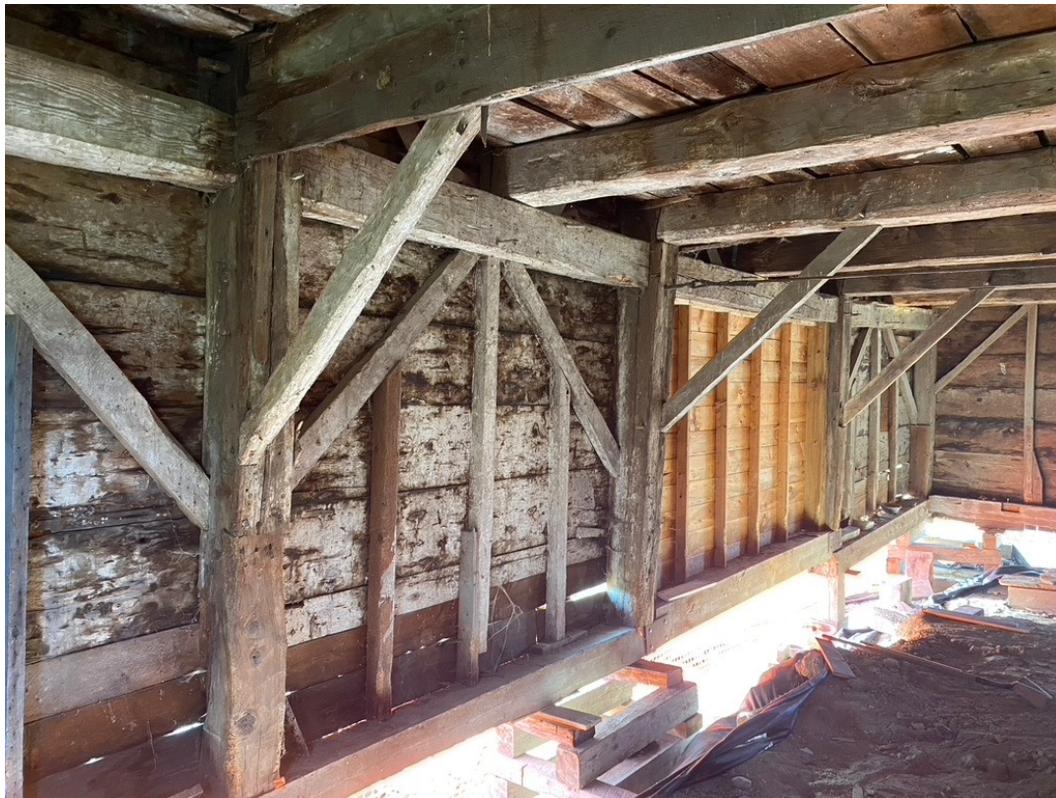
The completed trench with wooden support cribbing.

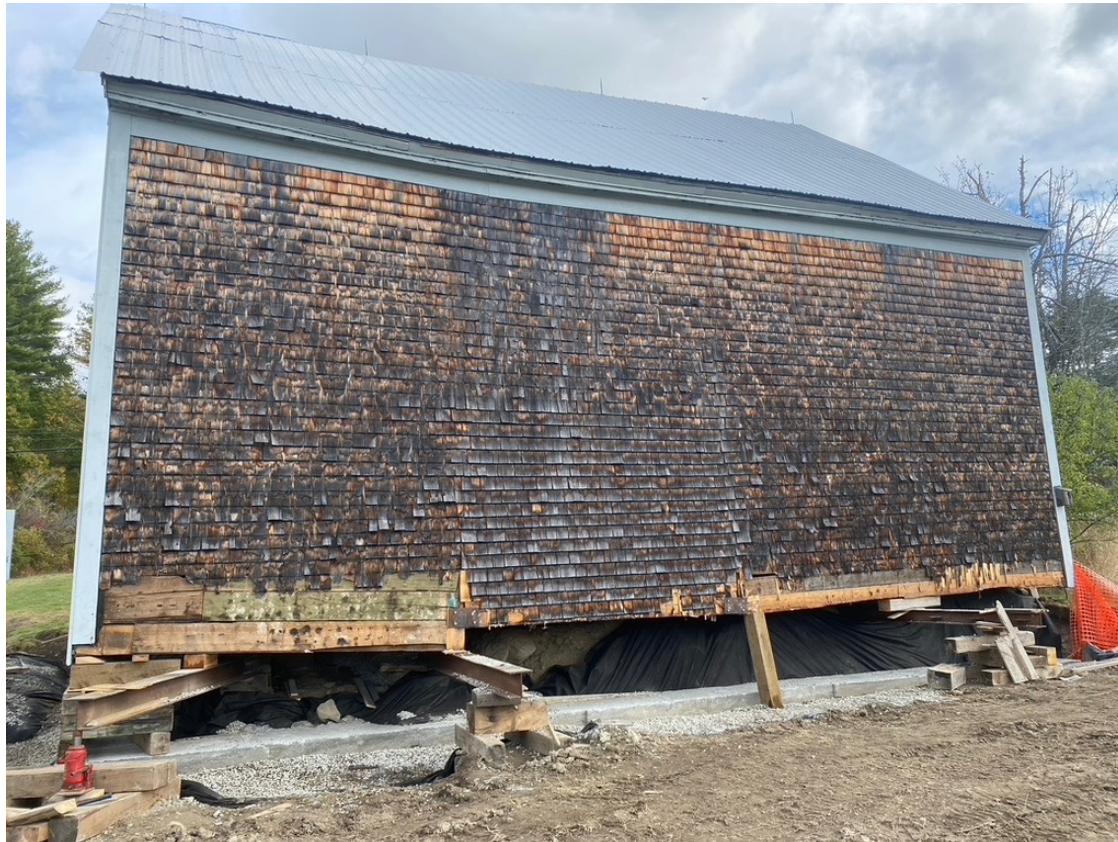
The completed west side concrete footing.

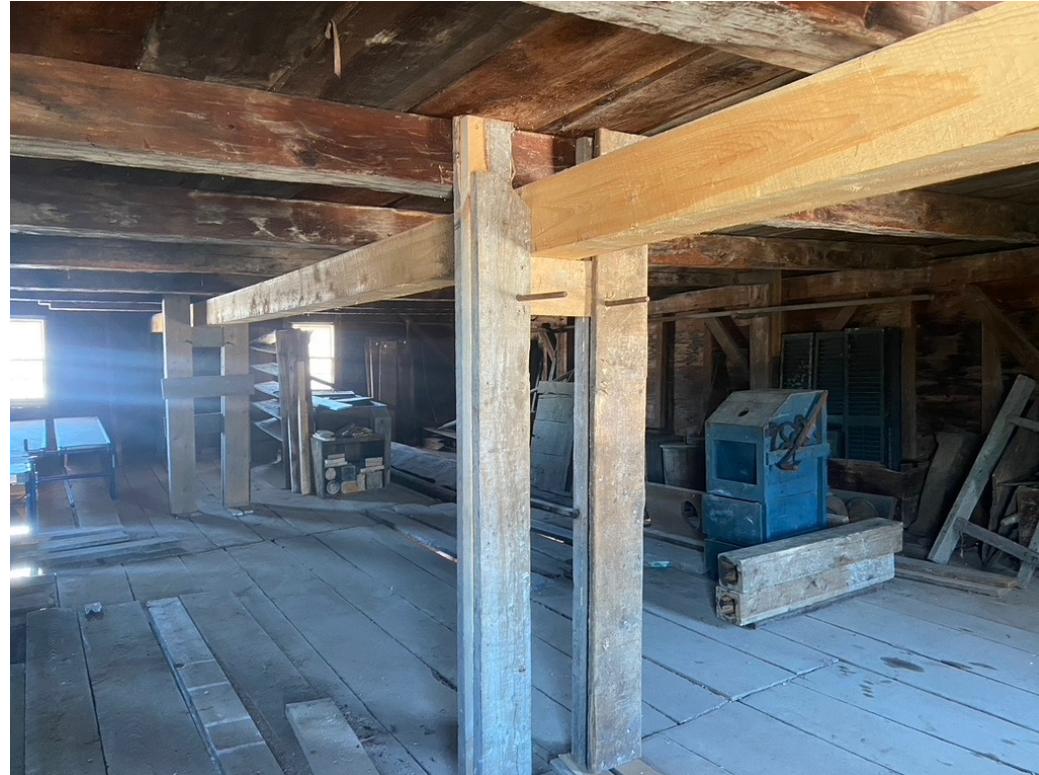
The 40-foot hemlock support beam on the second floor.

A matching beam was installed on the first floor.

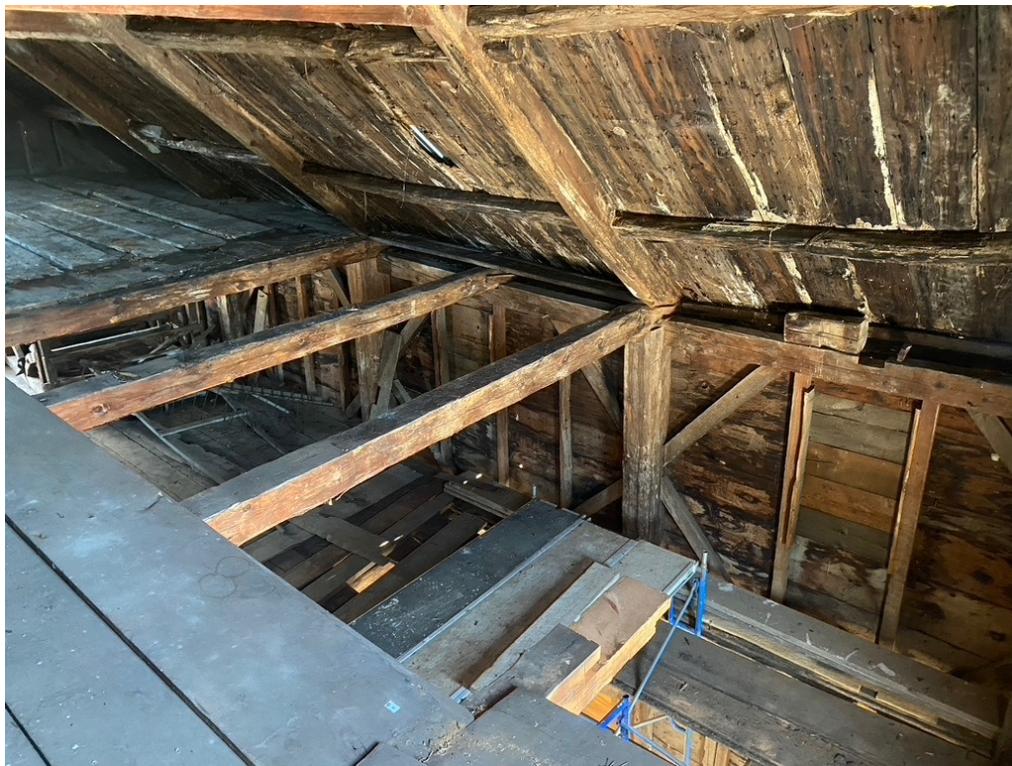
Rotted flooring was removed in preparation for work in 2026.

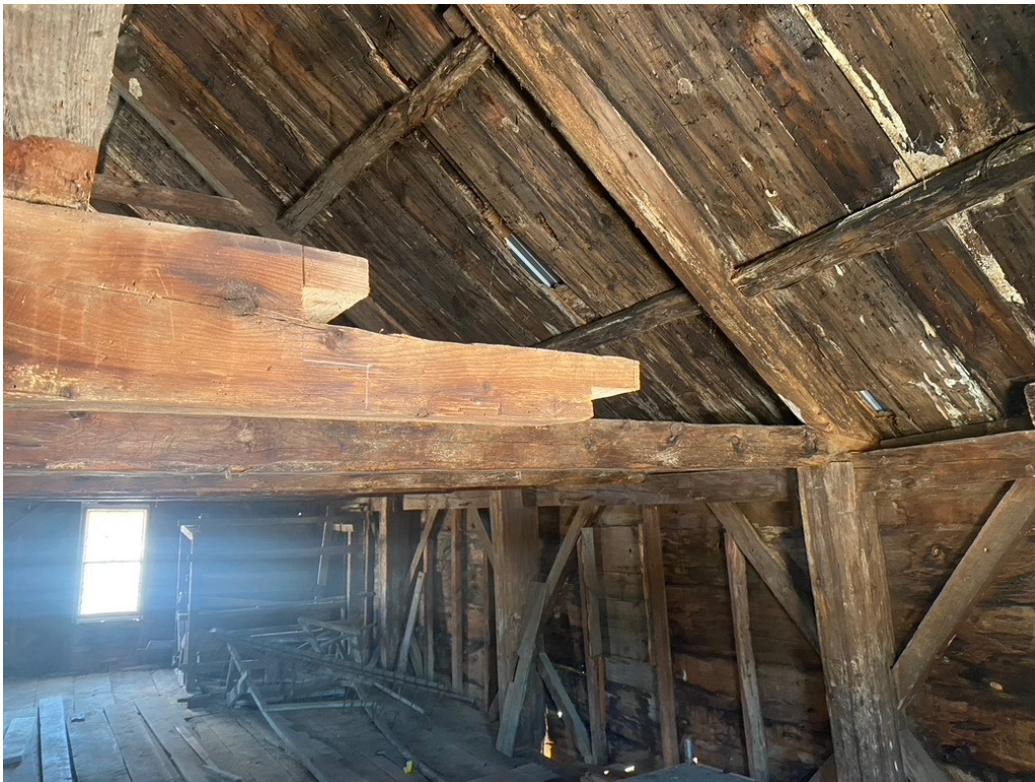
The collapsing floor joist beam with rotted wood removed, ready for splicing in 2026.
